ALABAMA DEPARTMENT OF ENVIRONMENTAL MANAGEMENT
 WATER DIVISION – INDUSTRIAL AND MUNICIPAL SECTIONS
NONCOMPLIANCE NOTIFICATION FORM

PERMITTEE NAME: Cahaba River WWTP PERMIT NO: AL0023027

DMR REPORTING PERIOD: September 2014

JEFFERSON COUNTY, ALABAMA
CAHABA RIVER AND TRUSSVILLE WWTPs PHASE I TMDL IMPROVEMENTS
Jefferson County Project No. E.01026.W.C / CDM Smith Project No. 73998-98293
SUBMITTAL REVIEW COMMENTS

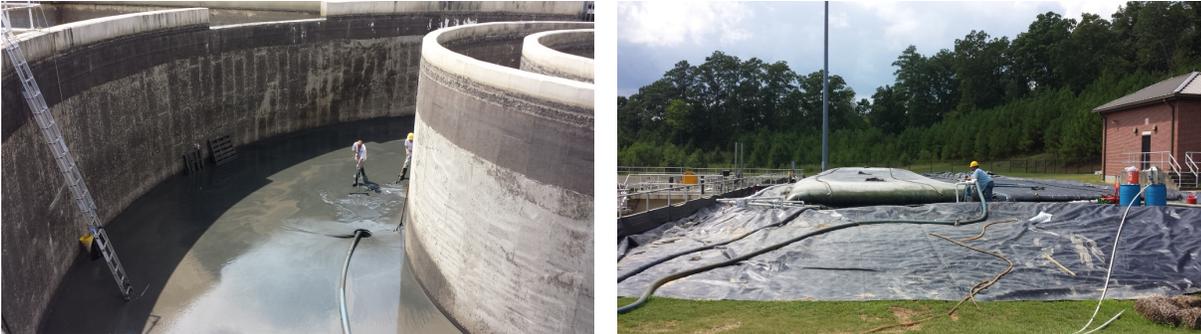
The below photos were taken on September 4, 2014 showing the current sludge removal and dewatering activities on the eastern carousel. The western BNR reactor is in service. In accordance with the plan, the average daily flow to the treatment plant was reduced to less than 6 MGD, the capacity of the western BNR reactor, by pumping more of the raw wastewater flow from the Al Seier pump station to the Valley Creek WWTP.
