ALABAMA DEPARTMENT OF ENVIRONMENTAL MANAGEMENT
 WATER DIVISION – INDUSTRIAL AND MUNICIPAL SECTIONS
NONCOMPLIANCE NOTIFICATION FORM

PERMITTEE NAME: Leeds WWTP PERMIT NO: AL0067067
 FACILITY LOCATION: 800 Helen Street Leeds, AL (Jefferson County)
 DMR REPORTING PERIOD: December 2014

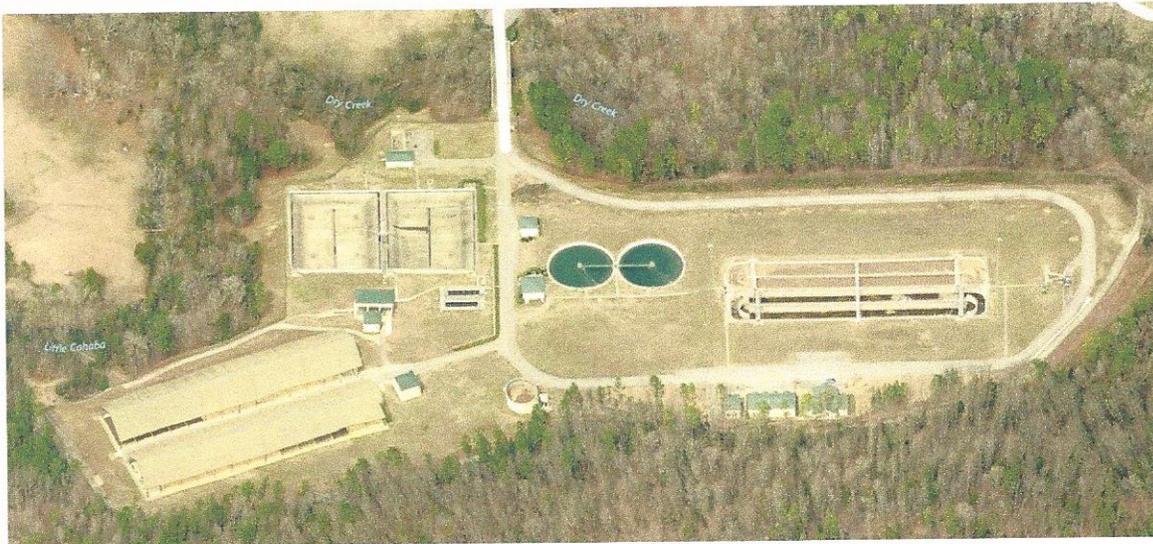
The weekly average ammonia concentration violation was caused by a biological upset in the activated sludge process. The weekly loading limit was not exceeded. The cause of the upset has been identified as equipment failure coupled with neglect-of-duty on the part of two operational staff and is further described below. The WWTP is staffed with certified WWTP operators 10-hours per day seven days per week.

The WWTP was constructed with two 2.5 MG aeration basins and only one is typically operated as shown in photo below. The active aeration basin (basin #2) experienced mechanical failures on two of the four brush rotors, so at approximately 8:30 a.m. Wednesday December 10, 2014, flow was transferred to basin #1. On Wednesday December 10, 2014, the instrumentation staff worked on the dissolved oxygen (D.O.) probe but could not complete the calibration because basin #1 was not yet full of water. The WWTP operational staff was instructed to monitor the system to make sure it operated correctly when it came into contact with the water because the brush rotor aerators are automatically controlled (turned on/off) by D.O. levels that are continuously monitored. The D.O. probe consistently read a false level between 1.5-1.6 mg/l which is below the set-point that turns on the rotors. The brush rotors did not operate from December 10, 2014 until 8:42 a.m. on December 15, 2014 when they were manually turned on by the Monday shift supervisor. The operators who worked between Thursday and Sunday failed to recognize the rotors did not run even though they recorded zero run hours on their daily log sheets. The operators were confused because SCADA showed animation with the aerators running. During this five day period, the aerobic nitrifying bacteria were stressed by the anaerobic conditions that had developed in basin #1. By Monday December 15, 2014, the basin had developed an odor and had settled solids because the submersible mixers do not provide complete mixing without the rotors in service.
