ALABAMA DEPARTMENT OF ENVIRONMENTAL MANAGEMENT
 WATER DIVISION – INDUSTRIAL AND MUNICIPAL SECTIONS
NONCOMPLIANCE NOTIFICATION FORM

PERMITTEE NAME: Cahaba River WWTP PERMIT NO: AL0023027

DMR REPORTING PERIOD: September 2014

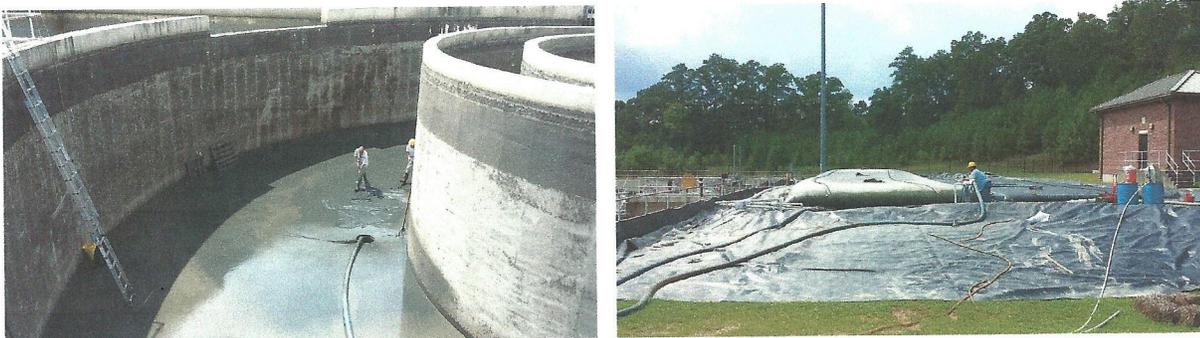
The below photos were taken on September 4, 2014 showing the current sludge removal and dewatering activities on the eastern carousel. The western BNR reactor is in service. In accordance with the plan, the average daily flow to the treatment plant was reduced to less than 6 MGD, the capacity of the western BNR reactor, by pumping more of the raw wastewater flow from the Al Seier pump station to the Valley Creek WWTP.
