ALABAMA DEPARTMENT OF ENVIRONMENTAL MANAGEMENT
 WATER DIVISION – INDUSTRIAL AND MUNICIPAL SECTIONS
NONCOMPLIANCE NOTIFICATION FORM

PERMITTEE NAME: Prudes Creek WWTP PERMIT NO: AL0056120
 FACILITY LOCATION: 500 Water Trail Graysville, AL 35073 (Jefferson County)
 DMR REPORTING PERIOD: September 2015

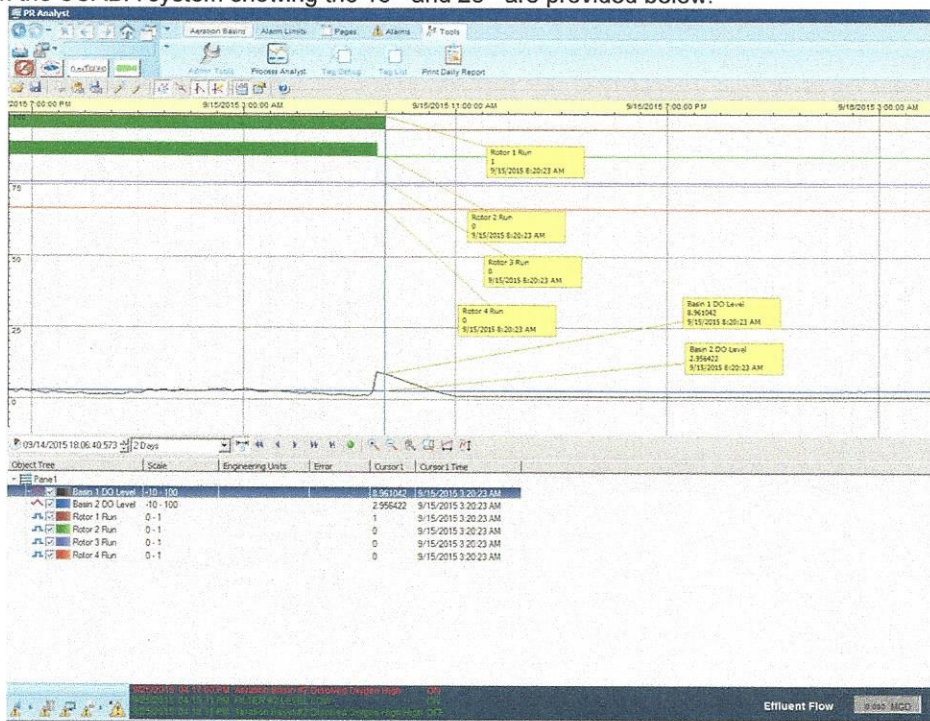
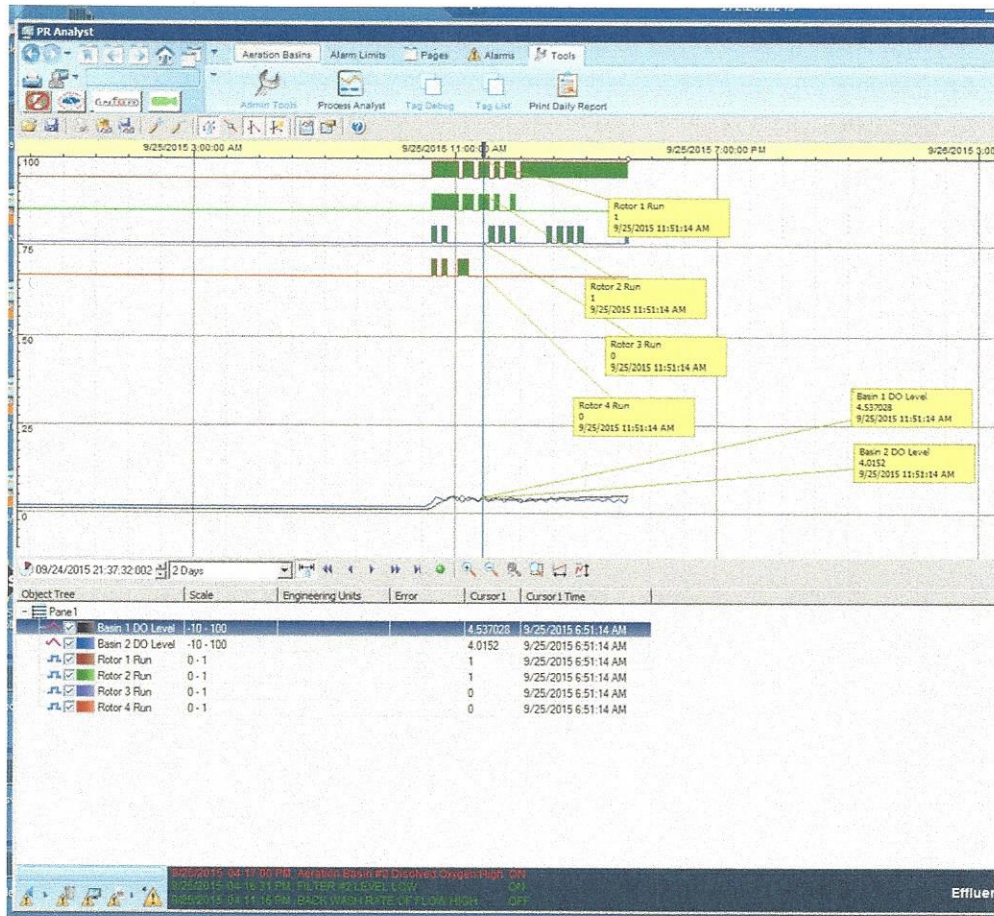
Between Tuesday September 15, 2015 and September 25, 2015, the dissolved oxygen (D.O.) probe on Aeration Basin #1 began to consistently display a false reading between 1.05 and 1.10 mg/l which is above the set-point that would have turned the rotors on if they had been running in the automatic control position. The D.O. readings are believed to be false because there were almost no variation between the minimum and maximum values recorded during this period. Aeration Basin #2 also showed unreliable D.O. readings. Per the logs in the SCADA system historian, the two brush rotors in Aeration Basin #1 and the two in Aeration basin #2 did not operate from 8:20 a.m. on September 15th until 10:15 a.m. on September 25, 2015 when they were found in the SCADA Manual (off) setting. Upon discovery, the rotors were changed to automatic control and began running. The operators who worked between the 15th and 25th failed to recognize the rotors were in an off-state and did not run even despite recording data which indicated zero run hours on their daily log sheets. During this ten day period, the aerobic nitrifying bacteria were likely stressed by the low D.O. conditions that had developed in basin #1, even though there were no indications of anaerobic conditions reported by the operators in Aeration Basin #1 or Aeration Basin #2.

Screen shots from the SCADA system showing the 15th and 25th are provided below.

Concurrent with the operational plans developed on the 25th, ESD management mobilized the electrical and instrumentation maintenance groups to investigate and correct the D.O. and TSS meter calibration and performance problems and the rotor run-time issues. The WWTP staff was later directed to pull the daily log sheets with the recorded run time for each rotor to provide additional data to determine the possible time frame for the rotor instrumentation failures.
